Manhole Inspection Summary

Manhole # S29EE1023MH

Insp Date: **12/20/06 1:32 PM**

Location Address: **3921 KESWICK RD**

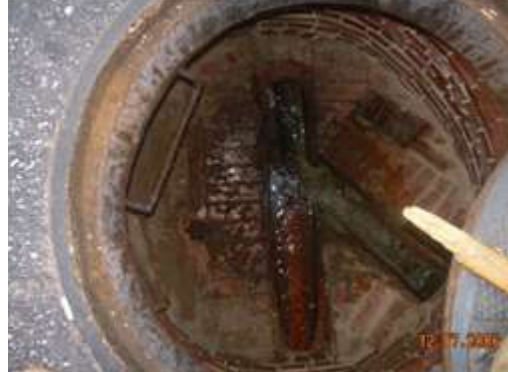
Top View

Bench debris.

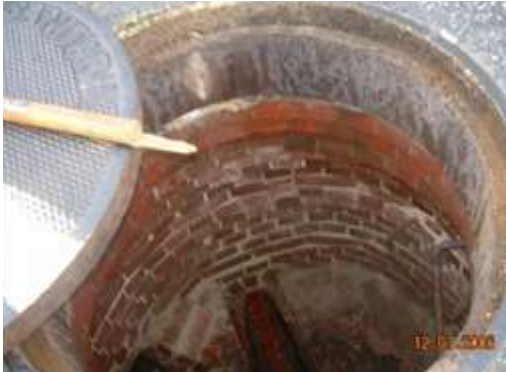
Defect

Condition: ☐ Sound ☐ Cracked ☐ Root Intrusion ☐ Loose Brick ☒ **Deteriorated**

Infiltration: ☐ None ☒ **Joint** ☐ Cracks ☒ **Mortar** ☐ Roots ☐ Wall

Adjustment deterioration and infiltration.
Corbel and Barrel infiltration.

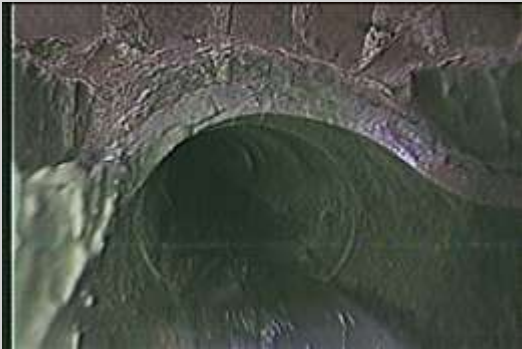
8 in. Circular Gravity Sewer Pipe Out @ 12 O'Clock

Infiltration: **Evidence** Pipe Seal Cond: **Cracked**

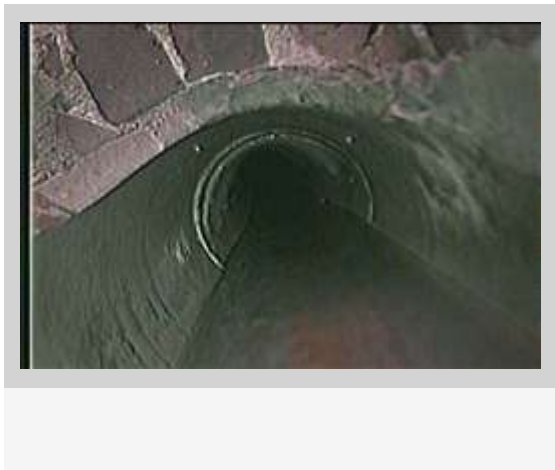
8 in. Circular Gravity Sewer
Pipe In @ 6 O'Clock

Deposits: ☐ None ☒ **Mud** ☐ Sludge ☒ **Debris** ☐ Grease

Silt Depth: **0.5** (in.) Deposits Extent: **Light**
